# Access Compliance Report Public Rights-of-Way (Curb Ramps)

Main Street: HEWES\_AVE Cross Street: VALE\_AVE Location: NE

ADA ID: RPAT211015131531 Ramp Type: Type 3 - Combination 1 Initial Pass/Fail: Fail Overall Compliance: No Severity Score: 30

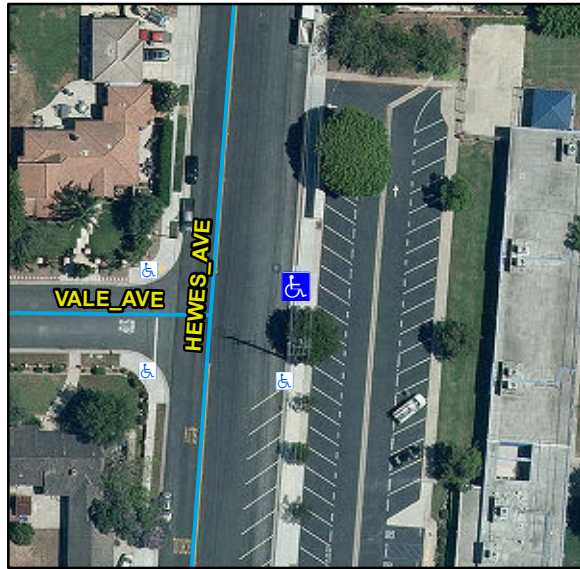
| Compliance | Description | Data | Compliance | Description | Data |
|---|---|---|---|---|---|
| No | Ramp Run Slope LT (%) | 8.8 | Yes | Ramp Run Slope RT (%) | 1.6 |
| No | Ramp Cross Slope LT (%) | 5.7 | Yes | Ramp Cross Slope RT (%) | 1.4 |

**Remove & Replace Entire Ramp.**

**R304.3.2, R304.5.3, STD 1115**
