# Access Compliance Report Public Rights-of-Way (Curb Ramps)

Main Street: **FORUM\_WAY** Cross Street: **TRIUMPHAL\_WAY** Location: **NW**

ADA ID: **RPAT211015142325** Ramp Type: **Type 1 - Perpendicular Diagonal** Initial Pass/Fail: **Pass** Overall Compliance: **No** Severity Score: **25**

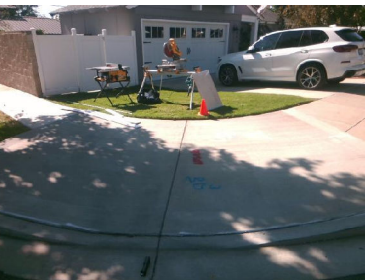
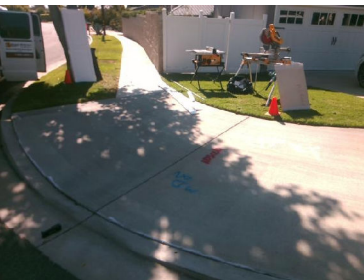
| Compliance | Description | Data | Compliance | Description | Data |
|---|---|---|---|---|---|
| <b>No</b> | Landing Width (in) | <b>N/A</b> | <b>N/A</b> | Flare Slope RT (%) | <b>7.2</b> |
| <b>No</b> | Landing Run Slope (%) | <b>N/A</b> | <b>N/A</b> | Flare Traversable RT | <b>No</b> |
| <b>No</b> | Landing Cross Slope (%) | <b>N/A</b> | <b>No</b> | DWS Provided | <b>No</b> |
| <b>Yes</b> | Gutter Ponding | <b>No</b> | <b>No</b> | Curb Slope | <b>8</b> |
| <b>No</b> | Gutter Run Slope (%) | <b>6</b> | | Road Cross Slope (%) | <b>4.9</b> |

**Remove & Replace Curb Ramp With Two New Directional Ramps or Equivalent. Remove & Replace Gutter.**
