# Access Compliance Report Public Rights-of-Way (Curb Ramps)

Main Street: TRIUMPHAL\_WAY Cross Street: SUBURNAS\_WAY Location: SW

ADA ID: RPAT211015142703 Ramp Type: Type 1 - Perpendicular Diagonal Initial Pass/Fail: Fail Overall Compliance: No Severity Score: 2

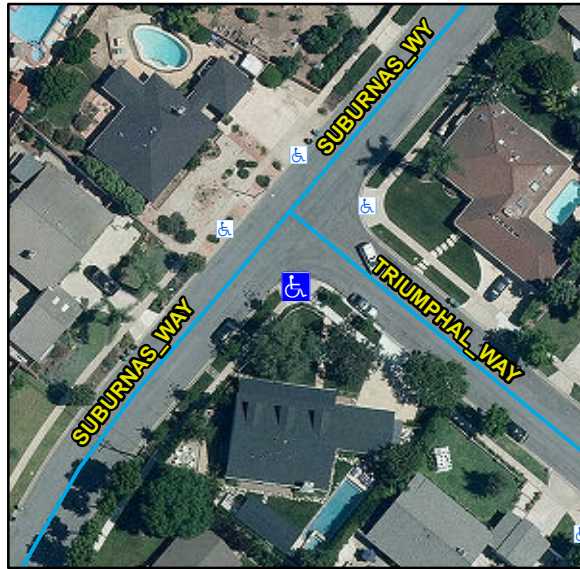
| Compliance | Description | Data | Compliance | Description | Data |
|---|---|---|---|---|---|
| No | Ramp Cross Slope (%) | 2.7 | N/A | Flare Traversable LT | N/A |

Remove & Replace Curb Ramp With Two New Directional Ramps or Equivalent.

R304.5.3, STD 1115
