# Access Compliance Report Public Rights-of-Way (Curb Ramps)

Main Street: SUBURNAS\_WY Cross Street: TRIUMPHAL\_WAY Location: SE

ADA ID: RPAT211015142930 Ramp Type: Type 1 - Perpendicular Diagonal Initial Pass/Fail: Pass Overall Compliance: No Severity Score: 20

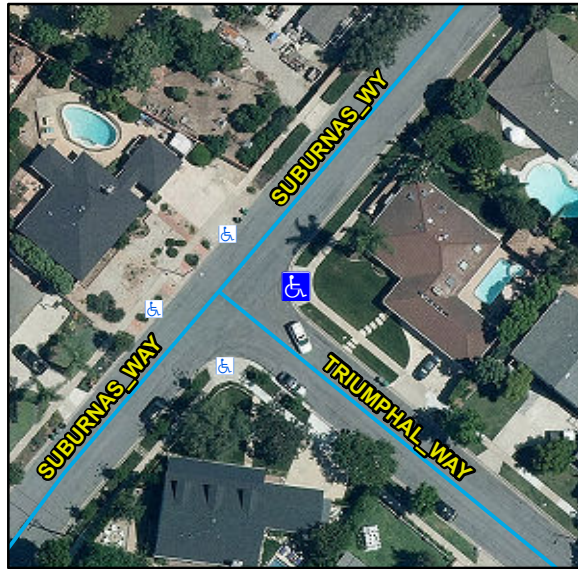
R204.3, R304.2.1, R304.2.2-Perp, R304.3.2-Para, R304.5.3, R305, STD 1115

Remove & Replace Curb Ramp With Two New Directional Ramps or Equivalent.

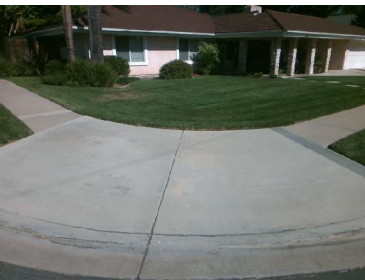
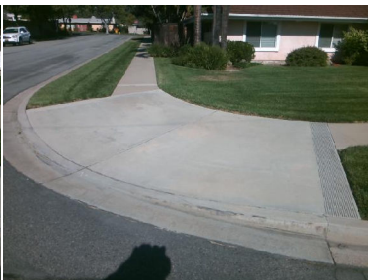
| Compliance | Description | Data | Compliance | Description | Data |
|---|---|---|---|---|---|
| No | Landing Width (in) | N/A | N/A | Flare Slope RT (%) | 4.2 |
| No | Landing Run Slope (%) | N/A | N/A | Flare Traversable RT | No |
| No | Landing Cross Slope (%) | N/A | No | DWS Provided | No |
| Yes | Overall Surface Condition: Acceptable | | No | Perp Joint Present | No |
