# Access Compliance Report Public Rights-of-Way (Curb Ramps)

Main Street: APPIAN\_WAY Cross Street: PINCIAN\_WAY Location: NE

ADA ID: RPAT211015143551 Ramp Type: Type 1 - Perpendicular Diagonal Initial Pass/Fail: Pass Overall Compliance: No Severity Score: 22

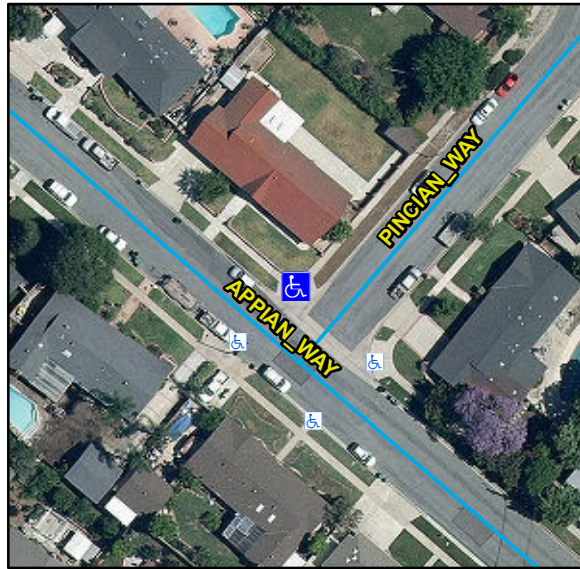
| Compliance | Description | Data | Compliance | Description | Data |
|---|---|---|---|---|---|
| No | Landing Width (in) | N/A | N/A | Flare Slope RT (%) | 5.5 |
| No | Landing Run Slope (%) | N/A | N/A | Flare Traversable RT | No |
| No | Landing Cross Slope (%) | N/A | No | DWS Provided | No |

Remove & Replace Curb Ramp With Two New Directional Ramps or Equivalent.
