# Access Compliance Report Public Rights-of-Way (Curb Ramps)

Main Street: PINCIAN\_WAY Cross Street: APPIAN\_WAY Location: SE

ADA ID: RPAT211015143840 Ramp Type: Type 1 - Perpendicular Diagonal Initial Pass/Fail: Pass Overall Compliance: No Severity Score: 22

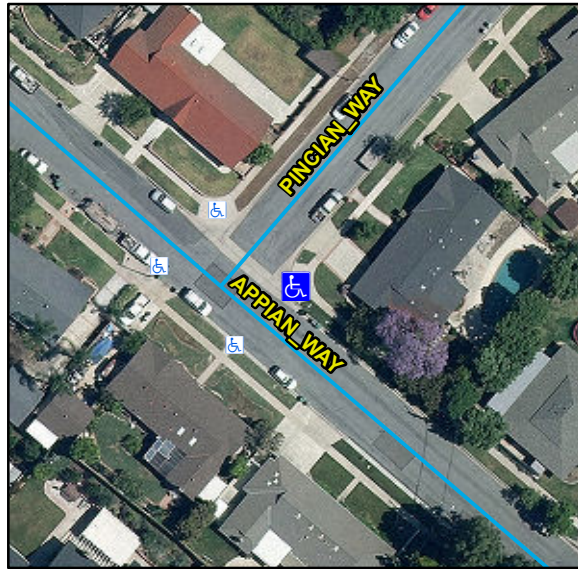
| Compliance | Description | Data | Compliance | Description | Data |
|---|---|---|---|---|---|
| No | Landing Width (in) | N/A | N/A | Flare Slope RT (%) | 3.2 |
| No | Landing Run Slope (%) | N/A | N/A | Flare Traversable RT | No |
| No | Landing Cross Slope (%) | N/A | No | DWS Provided | No |
| Yes | Gutter Ponding | No | No | Curb Slope | 11.5 |

Remove & Replace Curb Ramp With Two New Directional Ramps or Equivalent.
