# Access Compliance Report Public Rights-of-Way (Curb Ramps)

| Main Street: Foothill_BlvD | | Cross Street: SUBURNAS_WY | | Location: | SW |
| ADA ID: RPAT211018084823 | Ramp Type:Type 1 - Perpendicular Diagonal Initial Pass/Fail: Fail | | Overall Compliance: No | Severity Score: | 15 |

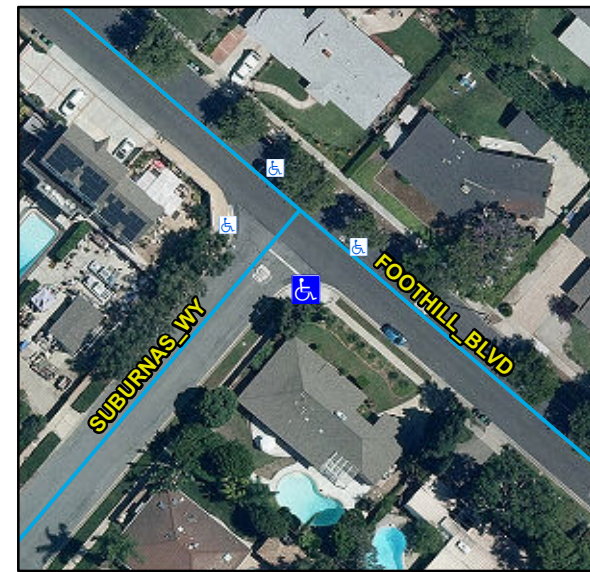
| Compliance | Description | Data | Compliance | Description | Data |
|---|---|---|---|---|---|
| No | Ramp Run Slope (%) | 9.3 | N/A | Flare Slope LT (%) | N/A |

Possible Solutions:

**Remove & Replace Curb Ramp With Two New Directional Ramps or Equivalent.**

**R304.2.2, STD 1115**

Total Cost: \$ 6160
