# Access Compliance Report Public Rights-of-Way (Curb Ramps)

| Main Street: SUBURNAS_WY | | Cross Street: FOOTHILL_BLVD | | Location: | W |
| ADA ID: RPAT211018085114 | Ramp Type: Type 6 - Directional 1 | Initial Pass/Fail: Pass | Overall Compliance: No | Severity Score: | 9 |

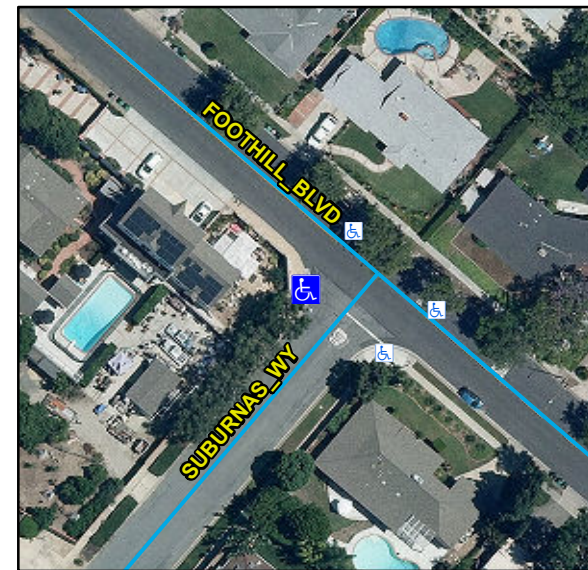
| Compliance | Description | Data | Compliance | Description | Data |
|---|---|---|---|---|---|
| No | Grade Break Cross Slope (%) | 3.3 | N/A | Flare Slope RT (%) | N/A |
| No | Landing Width (in) | 47 | Yes | DWS Full Width | Yes |
| No | Gutter Run Slope (%) | 5.2 | | Road Cross Slope (%) | 8.2 |
| No | Gutter Cross Slope (%) | 3.8 | | Parallel Ramp Side | N/A |

Remove & Replace Curb Ramp With Two New Directional Ramps or Equivalent. Remove & Replace Gutter.

R304.2.2, R304.2.1, R304.5.3, R304.5.4, STD 1115

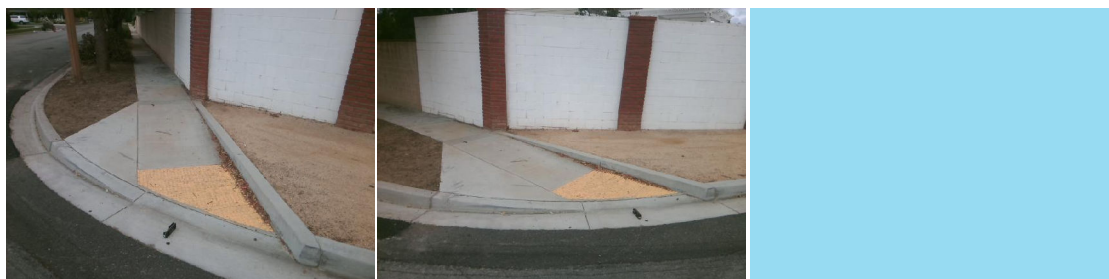
#### Obstruction and Utility Measurement/Component Compliance

| Compliance | Description | Data | Compliance | Description | Data |
| Yes | Obstructions Present? | No | N/A | Utilities Present? | No |
| | Obstruction Types | N/A | | Utility Types | |
| | Obstruction Dimensions | N/A | | | N/A |

#### Possible Solutions:
