# Access Compliance Report Public Rights-of-Way (Curb Ramps)

Main Street: NEWPORT\_AVE Cross Street: FOOTHILL\_BLVD Location: SE

ADA ID: RPAT211018091742 Ramp Type: Type 3 - Combination 1 Initial Pass/Fail: Fail Overall Compliance: No Severity Score: 25

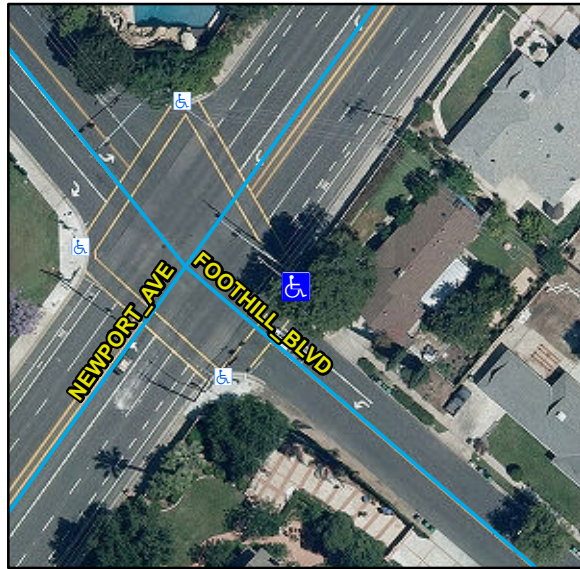
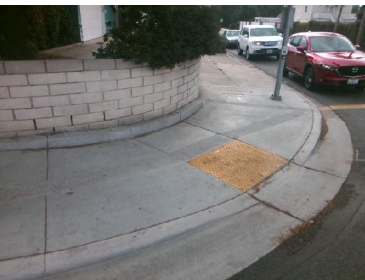
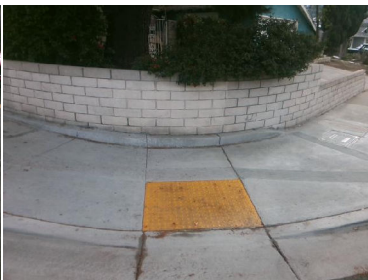
| Compliance | Description | Data | Compliance | Description | Data |
|---|---|---|---|---|---|
| No | Ramp Width LT (in) | 30 | No | Ramp Width RT (in) | 35 |
| Yes | Ramp Cross Slope LT (%) | 1.4 | No | Ramp Cross Slope RT (%) | 3 |
| N/A | Gutter Ponding | N/A | No | Curb Slope | 9.1 |

Remove & Replace Curb Ramp With Two New Directional Ramps or Equivalent. Remove & Replace Sidewalk.

R304.2.2, R304.5.1, R304.5.3, STD 1115
