# Access Compliance Report Public Rights-of-Way (Curb Ramps)

Main Street: Foothill\_BlvD Cross Street: Newport\_Ave Location: N

ADA ID: RPAT211018092846 Ramp Type: Type 1 - Perpendicular Diagonal Initial Pass/Fail: Fail Overall Compliance: No Severity Score: 2

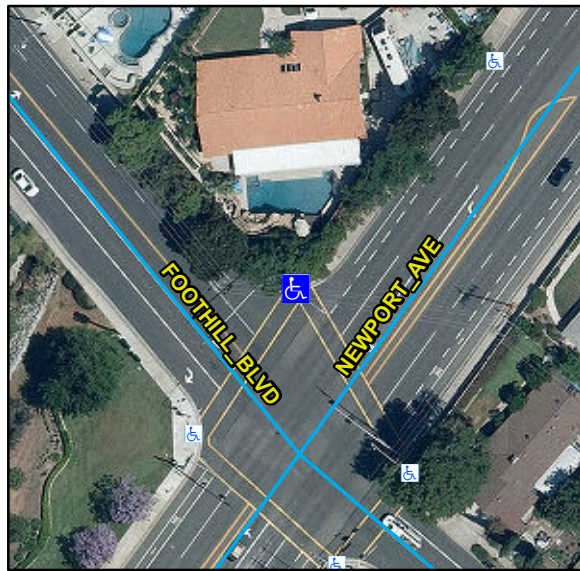
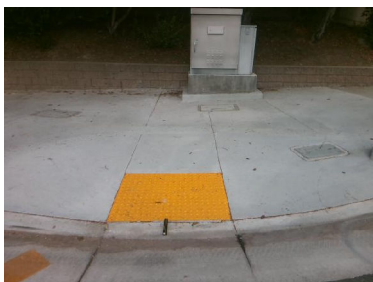
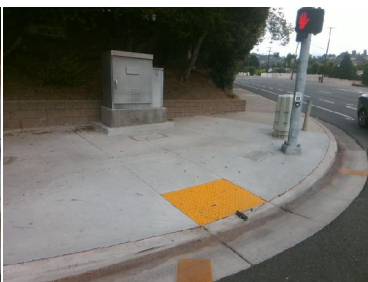
| Compliance | Description | Data | Compliance | Description | Data |
|---|---|---|---|---|---|
| No | Ramp Cross Slope (%) | 2.2 | N/A | Flare Traversable LT | N/A |
| N/A | Gutter Ponding | N/A | No | Curb Slope | 10.1 |

Remove & Replace Curb Ramp With Two New Directional Ramps or Equivalent.

R304.2.2, R304.5.3, STD 1115
