# Access Compliance Report Public Rights-of-Way (Curb Ramps)

Main Street: NEWPORT\_AVE Cross Street: FOOTHILL\_BLV Location: W

ADA ID: RPAT211018094140 Ramp Type:Type 1 - Perpendicular Diagonal Initial Pass/Fail: Pass Overall Compliance: No Severity Score: 0

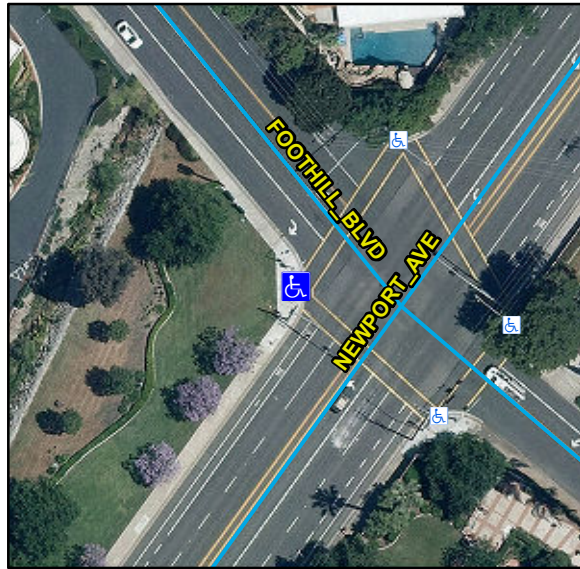
| Compliance | Description | Data | Compliance | Description | Data |
|---|---|---|---|---|---|
| No | Landing Run Slope (%) | 2.1 | N/A | Flare Traversable RT | No |
| Yes | Gutter Ponding | No | No | Curb Slope | 9.2 |
| No | Gutter Cross Slope (%) | 6.8 | | | |

Remove & Replace Curb Ramp With Two New Directional Ramps or Equivalent. Remove & Replace Gutter.

R304.2.2, R304.2.1, R304.2.2-Perp, R304.3.2-Para, R304.5.3, STD 1115
