# Access Compliance Report Public Rights-of-Way (Curb Ramps)

Main Street: SMOKE\_TREE\_LN Cross Street: NEWPORT\_AVE Location: S

ADA ID: RPAT211018095234 Ramp Type: Type 3 - Combination 1 Initial Pass/Fail: Fail Overall Compliance: No Severity Score: 2

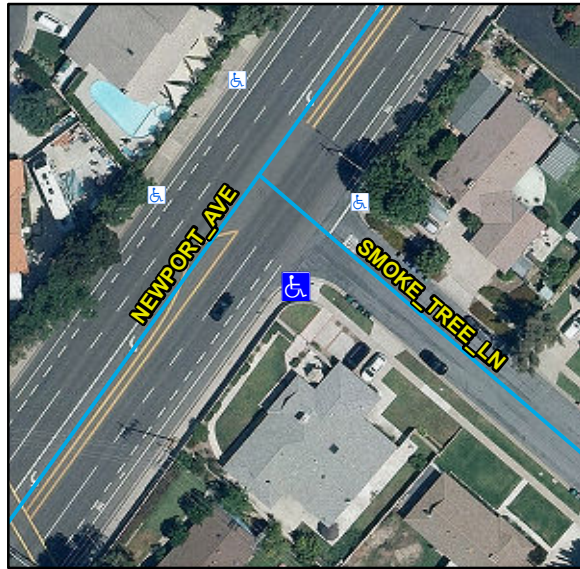
| Compliance | Description | Data | Compliance | Description | Data |
|---|---|---|---|---|---|
| No | Ramp Cross Slope LT (%) | 3 | No | Ramp Cross Slope RT (%) | 3.3 |
| N/A | Gutter Ponding | N/A | No | Curb Slope | 11.4 |

**Remove & Replace Curb Ramp With Two New Directional Ramps or Equivalent.**

**R304.2.2, R304.5.3, STD 1115**

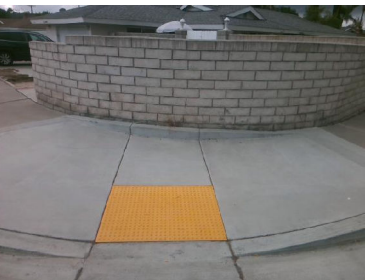
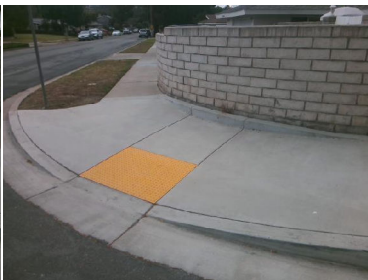
| Compliance | Description | Data | Compliance | Description | Data |
|---|---|---|---|---|---|
| N/A | Ramp Length LT (in) | 66 | N/A | Ramp Length RT (in) | 99 |
| Yes | Ramp Width LT (in) | 53 | Yes | Ramp Width RT (in) | 60 |
| Yes | Ramp Run Slope LT (%) | 7.6 | Yes | Ramp Run Slope RT (%) | 5.1 |
