# Access Compliance Report Public Rights-of-Way (Curb Ramps)

Main Street: NEWPORT\_AVE Cross Street: SMOKE\_TREE\_LN Location: E

ADA ID: RPAT211018095935 Ramp Type: Type 1 - Perpendicular Diagonal Initial Pass/Fail: Fail Overall Compliance: No Severity Score: 5

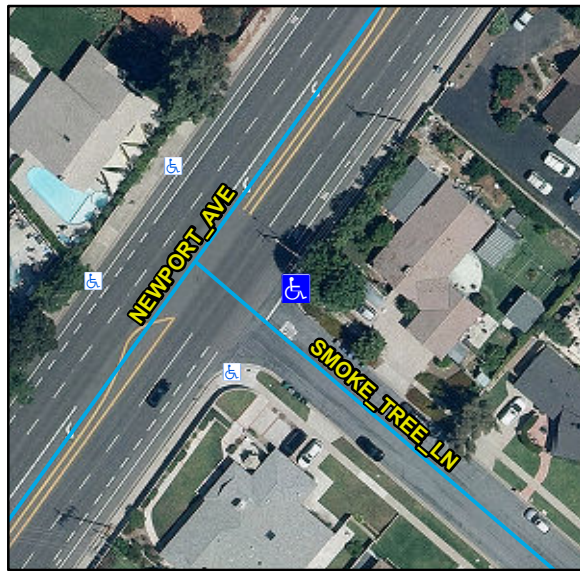
R304.2.2, R304.5.1, R304.5.3, STD 1115

| Compliance | Description | Data | Compliance | Description | Data |
|---|---|---|---|---|---|
| No | Ramp Width (in) | 47 | | | N/A |
| No | Ramp Cross Slope (%) | 3.9 | N/A | Flare Traversable LT | N/A |

Remove & Replace Curb Ramp With Two New Directional Ramps or Equivalent.
