# Access Compliance Report Public Rights-of-Way (Curb Ramps)

Main Street: ST\_JOHN\_PL Cross Street: NEWPORT\_AVE Location: SW

ADA ID: RPAT211018100649 Ramp Type: Type 1 - Perpendicular Diagonal Initial Pass/Fail: Fail Overall Compliance: No Severity Score: 2

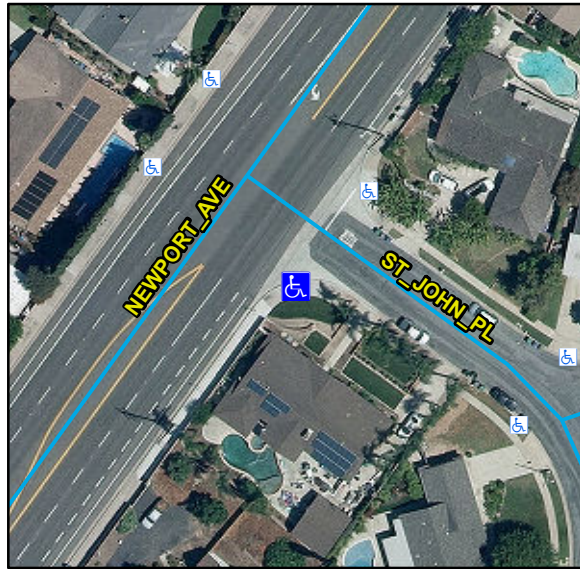
| Compliance | Description | Data | Compliance | Description | Data |
|---|---|---|---|---|---|
| No | Ramp Cross Slope (%) | 4 | N/A | Flare Traversable LT | N/A |

Remove & Replace Curb Ramp With Two New Directional Ramps or Equivalent.

R304.2.2, R304.5.3, STD 1115
