# Access Compliance Report Public Rights-of-Way (Curb Ramps)

Main Street: NEWPORT\_AVE Cross Street: ST\_JOHN\_PL Location: SE

ADA ID: RPAT211018101139 Ramp Type: Type 1 - Perpendicular Diagonal Initial Pass/Fail: Fail Overall Compliance: No Severity Score: 2

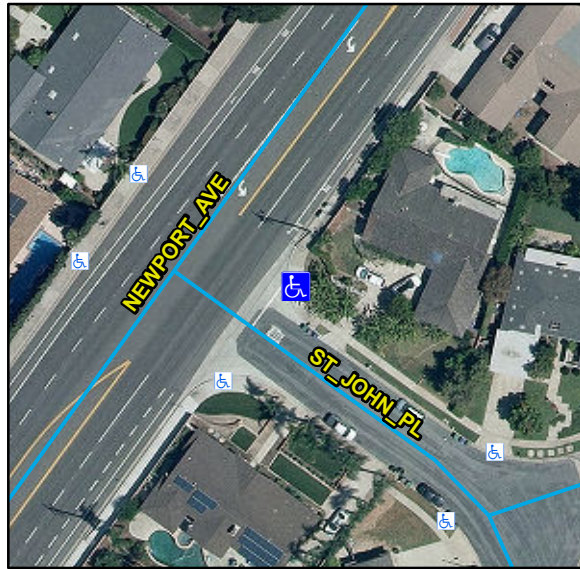
| Compliance | Description | Data | Compliance | Description | Data |
|---|---|---|---|---|---|
| No | Ramp Cross Slope (%) | 3.4 | N/A | Flare Traversable LT | N/A |

Remove & Replace Curb Ramp With Two New Directional Ramps or Equivalent. Replace Spandrel.
