# Access Compliance Report Public Rights-of-Way (Curb Ramps)

Main Street: DODGE\_AVE Cross Street: NEWPORT\_AVE Location: N

ADA ID: RPAT211018103541 Ramp Type: Type 3 - Combination 1 Initial Pass/Fail: Fail Overall Compliance: No Severity Score: 4

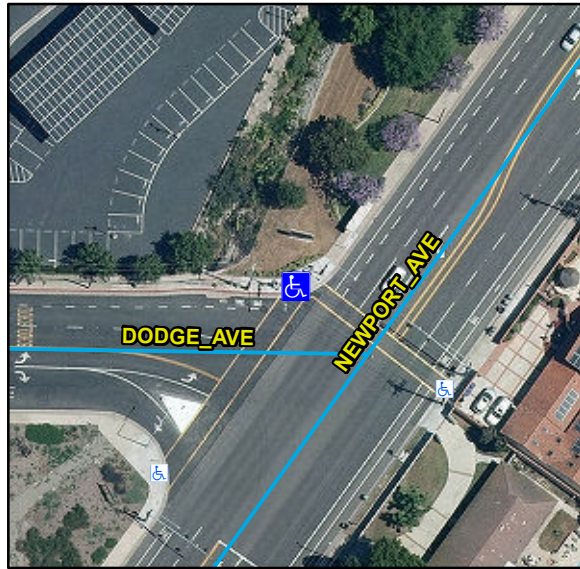
| Compliance | Description | Data | Compliance | Description | Data |
|---|---|---|---|---|---|
| No | Ramp Width LT (in) | 43 | Yes | Ramp Width RT (in) | 54 |
| N/A | Gutter Ponding | N/A | No | Curb Slope | 11 |

**Remove & Replace Curb Ramp With Two New Directional Ramps or Equivalent. Remove & Replace Sidewalk.**

**R304.2.2, R304.5.1, STD 1115**

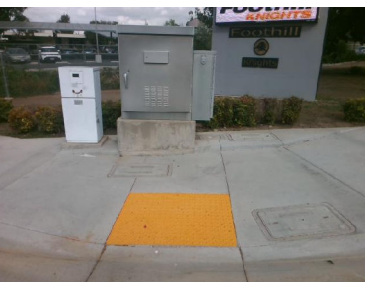
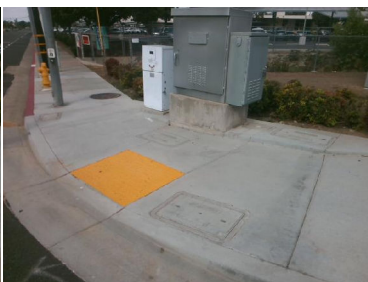
| Compliance | Description | Data | Compliance | Description | Data |
|---|---|---|---|---|---|
| | Obstruction Dimensions | N/A | | Control Box; Pull Box | |
