# Access Compliance Report Public Rights-of-Way (Curb Ramps)

Main Street: DODGE\_AVE Cross Street: NEWPORT\_AVE Location: SW

ADA ID: RPAT211018104437 Ramp Type: Type 1 - Perpendicular Initial Pass/Fail: Pass Overall Compliance: No Severity Score: 2

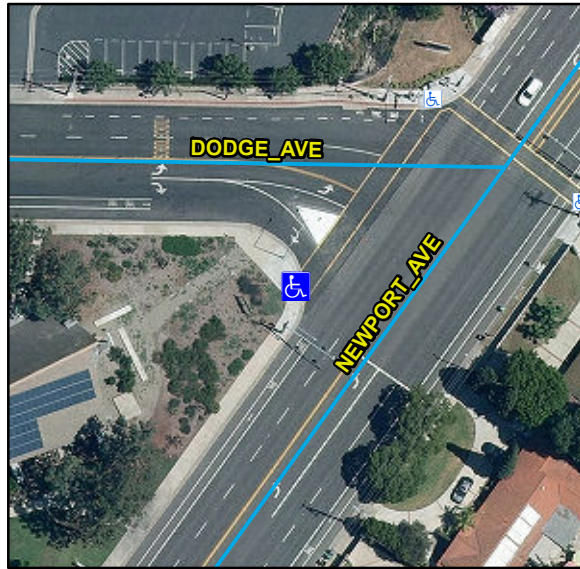
| Compliance | Description | Data | Compliance | Description | Data |
|---|---|---|---|---|---|
| Yes | Gutter Ponding | No | No | Curb Slope | 10 |

Remove & Replace Entire Ramp.

R304.2.2, R304.2.1, STD 1115

Total Cost: \$ 3080
