# Access Compliance Report Public Rights-of-Way (Curb Ramps)

Main Street: WHEMBLY\_DR Cross Street: DODGE\_AVE Location: SW

ADA ID: RPAT211018112732 Ramp Type: Type 3 - Combination 1 Initial Pass/Fail: Pass Overall Compliance: No Severity Score: 4

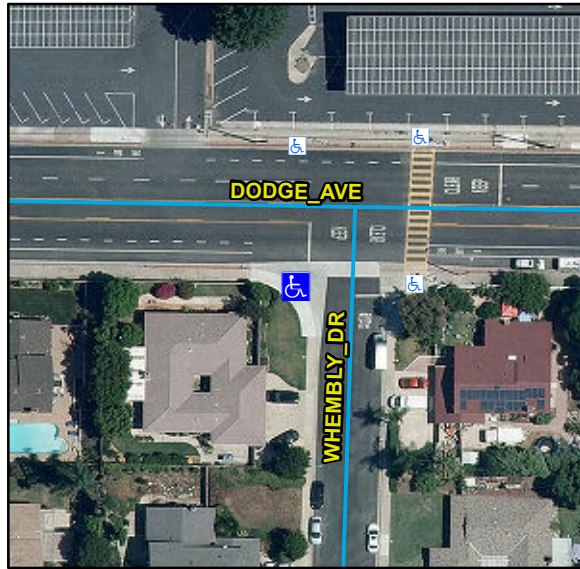
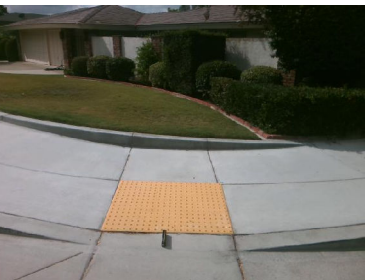
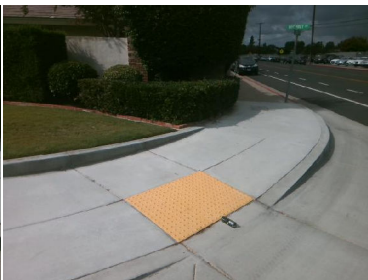
| Compliance | Description | Data | Compliance | Description | Data |
|---|---|---|---|---|---|
| No | Landing Length (in) | 47 | | | Sloped |

**Remove & Replace Landing.**

**R304.2.1, STD 1115**
