# Access Compliance Report Public Rights-of-Way (Curb Ramps)

Main Street: DODGE\_AVE Cross Street: WHEMBLY\_DR Location: SE

ADA ID: RPAT211018113339 Ramp Type: Type 3 - Combination 1 Initial Pass/Fail: Fail Overall Compliance: No Severity Score: 14

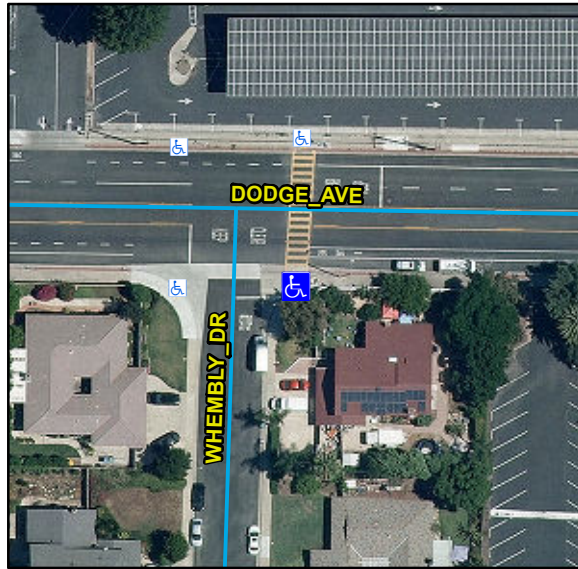
| Compliance | Description | Data | Compliance | Description | Data |
|---|---|---|---|---|---|
| No | Ramp Width LT (in) | 34 | No | Ramp Width RT (in) | 35 |
| No | Ramp Cross Slope LT (%) | 2.3 | Yes | Ramp Cross Slope RT (%) | 1.2 |

**Remove & Replace Curb Ramp With Two New Directional Ramps or Equivalent.**

**R304.2.2, R304.5.1, R304.5.3, STD 1115**
