# Access Compliance Report Public Rights-of-Way (Curb Ramps)

Main Street: DODGE\_AVE Cross Street: WHEMBLY\_DR Location: NE

ADA ID: RPAT211018114644 Ramp Type: Type 3 - Combination 1 Initial Pass/Fail: Fail Overall Compliance: No Severity Score: 14

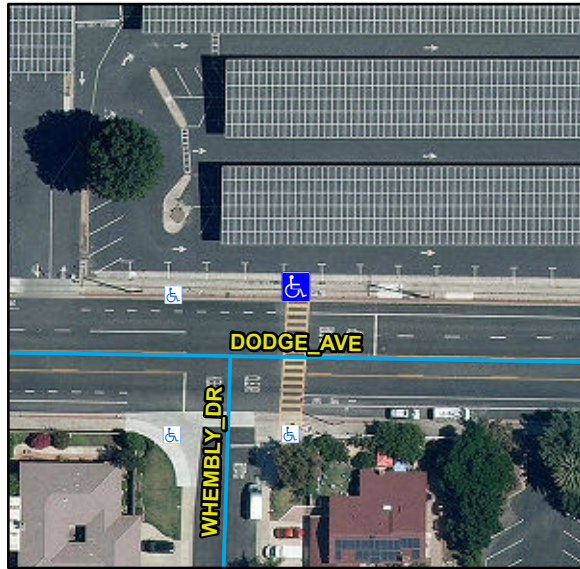
| Compliance | Description | Data | Compliance | Description | Data |
|---|---|---|---|---|---|
| No | Obstructions Present? | Yes | N/A | Utilities Present? | No |
| | Obstruction Types | Pushbutton Post | | Utility Types | |

| Compliance | Description | Data | Compliance | Description | Data |
|---|---|---|---|---|---|
| No | Ramp Width LT (in) | 35 | No | Ramp Width RT (in) | 35 |

**Remove & Replace Entire Ramp. Remove & Replace Sidewalk.**

**R304.5.1, R302.3, R402.2, STD 1115**
