# Access Compliance Report Public Rights-of-Way (Curb Ramps)

Main Street: WOODGLEN\_DR Cross Street: DODGE\_AVE Location: SW

ADA ID: RPAT211018115922 Ramp Type: Type 3 - Combination 1 Initial Pass/Fail: Pass Overall Compliance: No Severity Score: 6

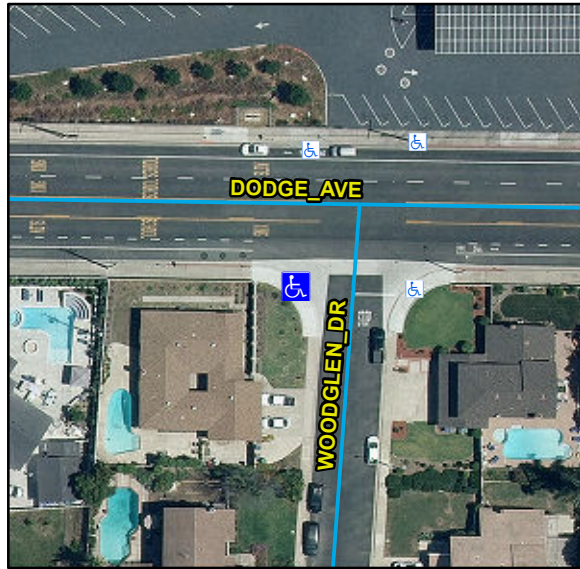
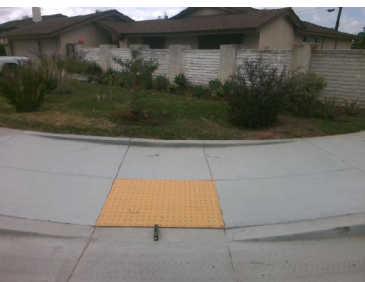
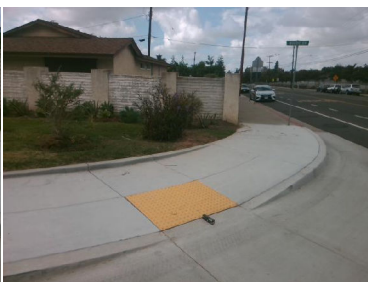
| Compliance | Description | Data | Compliance | Description | Data |
|---|---|---|---|---|---|
| No | Landing Length (in) | 47 | | | Sloped |
| No | Gutter Cross Slope (%) | 2.4 | | | |
| Yes | Overall Surface Condition: <b>Acceptable</b> | | | | |

**Remove & Replace Landing. Remove & Replace Gutter.**

**R304.2.1, R304.5.3, STD 1115**
