# Access Compliance Report Public Rights-of-Way (Curb Ramps)

Main Street: DODGE\_AVE Cross Street: WOODGLEN\_DR Location: NW

ADA ID: RPAT211018120409 Ramp Type: Type 1 - Perpendicular Initial Pass/Fail: Fail Overall Compliance: No Severity Score: 15

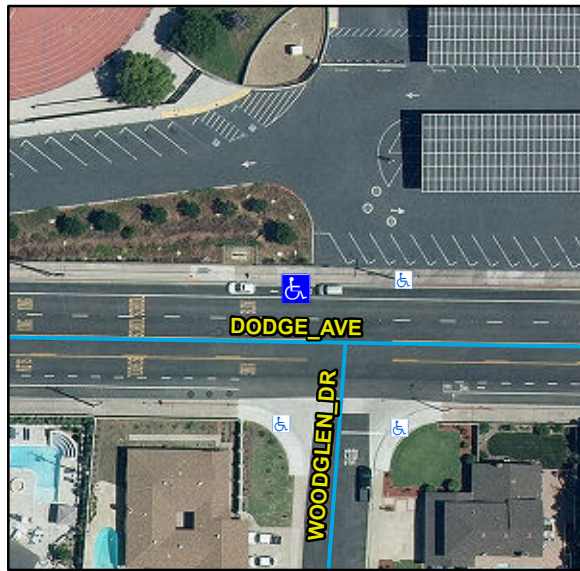
| Compliance | Description | Data | Compliance | Description | Data |
|---|---|---|---|---|---|
| No | Ramp Run Slope (%) | 8.6 | N/A | Flare Slope LT (%) | N/A |
| N/A | Gutter Ponding | N/A | No | Curb Slope | 15.6 |

Possible Solutions:

**Remove & Replace Entire Ramp.**

**R304.2.2, STD 1115**

Total Cost: \$ 3080
