# Access Compliance Report Public Rights-of-Way (Curb Ramps)

Main Street: TEA\_HOUSE\_ST Cross Street: DODGE\_AVE Location: SW

ADA ID: RPAT211018134957 Ramp Type: Type 1 - Perpendicular Diagonal Initial Pass/Fail: Fail Overall Compliance: No Severity Score: 4

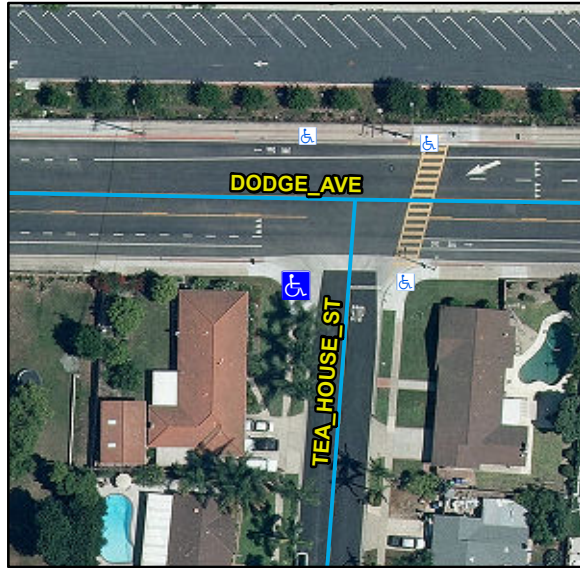
| Compliance | Description | Data | Compliance | Description | Data |
|---|---|---|---|---|---|
| No | Ramp Width (in) | 47 | | | N/A |

Remove & Replace Curb Ramp With Two New Directional Ramps or Equivalent.
