# Access Compliance Report Public Rights-of-Way (Curb Ramps)

Main Street: DODGE\_AVE Cross Street: TEA\_HOUSE\_ST Location: SE

ADA ID: RPAT211018135315 Ramp Type: Type 3 - Combination 1 Initial Pass/Fail: Fail Overall Compliance: No Severity Score: 4

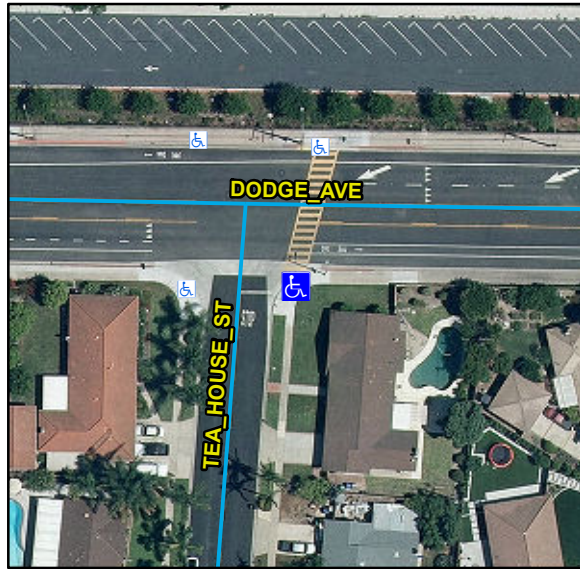
| Compliance | Description | Data | Compliance | Description | Data |
|---|---|---|---|---|---|
| No | Ramp Width LT (in) | 47 | Yes | Ramp Width RT (in) | 48 |

**Remove & Replace Curb Ramp With Two New Directional Ramps or Equivalent.**

**R204.3, R304.5.1, STD 1115**
