# Access Compliance Report Public Rights-of-Way (Curb Ramps)

Main Street: DODGE\_AVE Cross Street: TEA\_HOUSE\_ST Location: NE

ADA ID: RPAT211018135729 Ramp Type: Type 3 - Combination 1 Initial Pass/Fail: Fail Overall Compliance: No Severity Score: 4

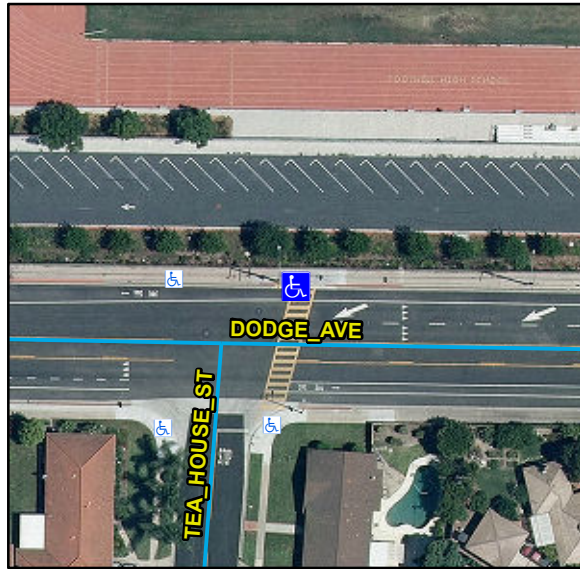
| Compliance | Description | Data | Compliance | Description | Data |
|---|---|---|---|---|---|
| No | Ramp Width LT (in) | 43 | No | Ramp Width RT (in) | 44 |
| No | Perp Joint Present | No | | | |
| N/A | Gutter Ponding | N/A | No | Curb Slope | 7.6 |

**Remove & Replace Entire Ramp. Remove & Replace Sidewalk.**

**R304.2.2, R204.3, R304.5.1, STD 1115**
