# Access Compliance Report

## Public Rights-of-Way

### (Curb Ramps)

Main Street: TEA\_HOUSE\_ST Cross Street: EMPEROR\_DR Location: E

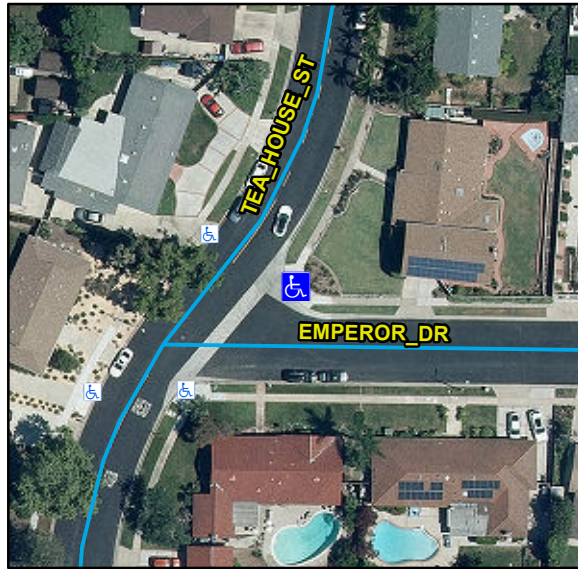
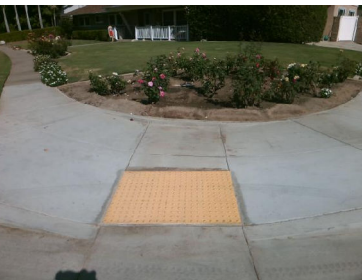
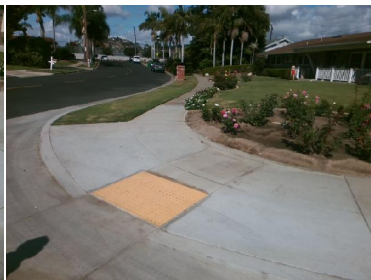
ADA ID: RPAT211018140409 Ramp Type: Type 3 - Combination 1 Initial Pass/Fail: Pass Overall Compliance: No Severity Score: 4

| Compliance | Description | Data | Compliance | Description | Data |
|---|---|---|---|---|---|
| No | Landing Length (in) | 47 | | | Sloped |

Remove & Replace Landing.

R304.2.1, STD 1115
