# Access Compliance Report Public Rights-of-Way (Curb Ramps)

Main Street: LINDA\_LN Cross Street: PROSPECT\_AVE Location: SW

ADA ID: RPAT211018143952 Ramp Type: Type 7 - Directional 2 Initial Pass/Fail: Fail Overall Compliance: No Severity Score: 30

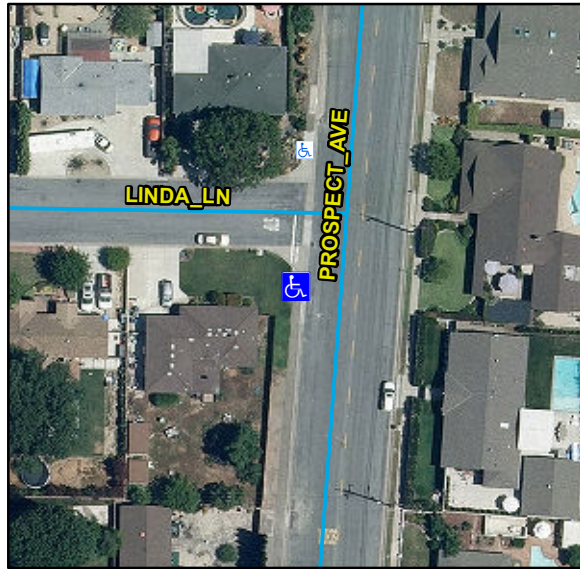
| Compliance | Description | Data | Compliance | Description | Data |
|---|---|---|---|---|---|
| No | Ramp Cross Slope (%) | 8.4 | N/A | Flare Traversable LT | N/A |

Possible Solutions:

Remove & Replace Entire Ramp.

R204.3, R304.5.3, STD 1115
