# Access Compliance Report Public Rights-of-Way (Curb Ramps)

Main Street: LINDA\_LN Cross Street: PROSPECT\_AVE Location: NW

ADA ID: RPAT211018144255 Ramp Type: Type 7 - Directional 2 Initial Pass/Fail: Fail Overall Compliance: No Severity Score: 15

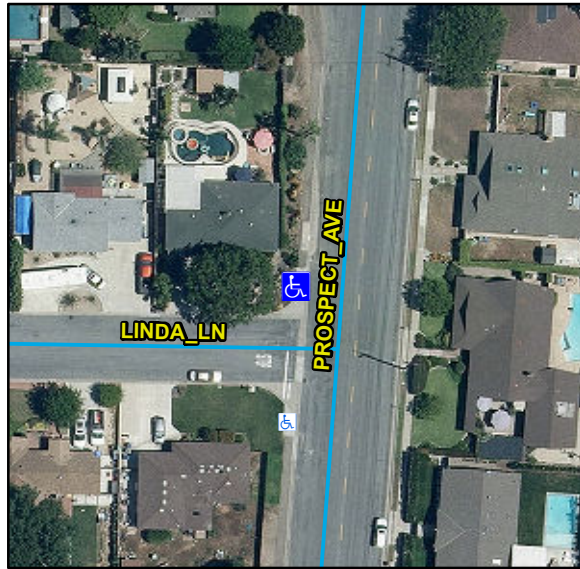
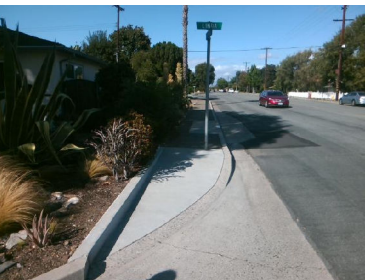
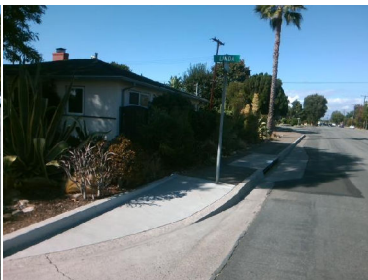
| Compliance | Description | Data | Compliance | Description | Data |
|---|---|---|---|---|---|
| <b>No</b> | Ramp Cross Slope (%) | <b>6.8</b> | <b>N/A</b> | Flare Traversable LT | <b>N/A</b> |

**Remove & Replace Entire Ramp.**

**R204.3, R304.5.3, STD 1115**
