# Access Compliance Report Public Rights-of-Way (Curb Ramps)

| Main Street: LAURIE_LN | | Cross Street: PROSPECT_AVE | | Location: | NW |
| ADA ID: RPAT211018144712 | Ramp Type: Type 7 - Directional 2 | Initial Pass/Fail: Fail | Overall Compliance: No | Severity Score: | 15 |

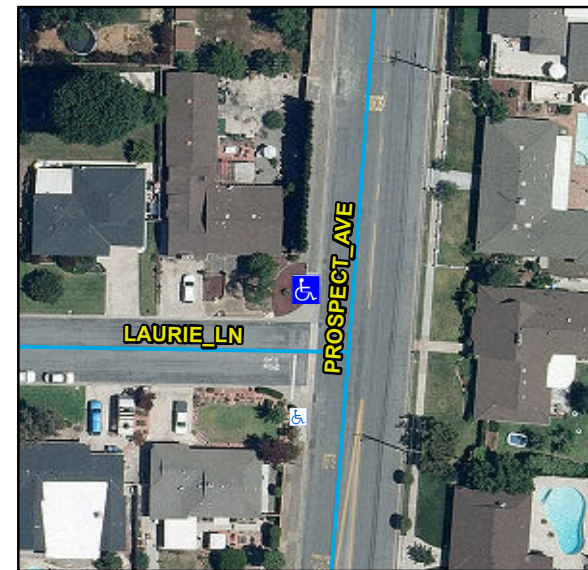
| Compliance | Description | Data | Compliance | Description | Data |
|---|---|---|---|---|---|
| No | Ramp Cross Slope (%) | 6.8 | N/A | Flare Traversable LT | N/A |

Possible Solutions:

Remove & Replace Entire Ramp.

R204.3, R304.5.3, STD 1115
