# Access Compliance Report Public Rights-of-Way (Curb Ramps)

Main Street: LEAFWOOD\_LN Cross Street: PROSPECT\_AVE Location: NW

ADA ID: RPAT211018150712 Ramp Type: Type 3 - Combination 1 Initial Pass/Fail: Fail Overall Compliance: No Severity Score: 4

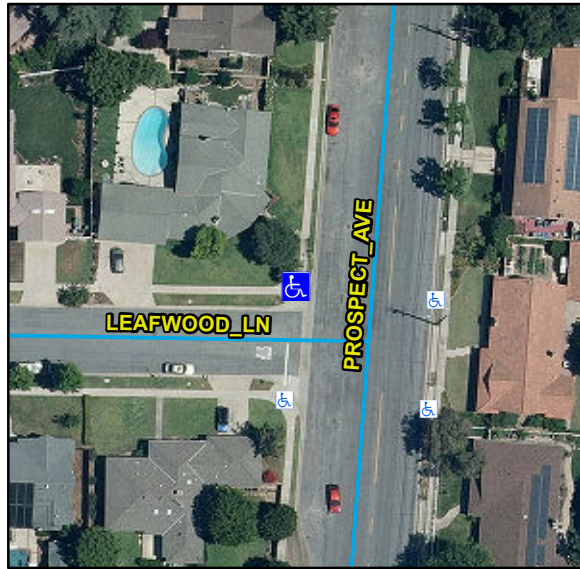
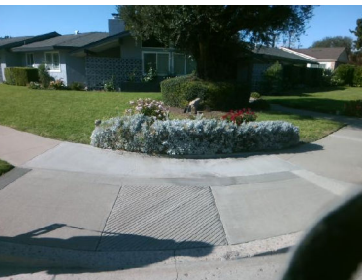
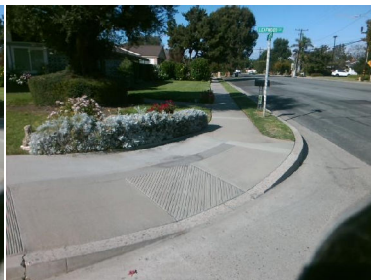
| Compliance | Description | Data | Compliance | Description | Data |
|---|---|---|---|---|---|
| Yes | Ramp Width LT (in) | 48 | No | Ramp Width RT (in) | 38 |
| No | Ramp Width (in) | 47 | | | N/A |
| N/A | Gutter Ponding | N/A | No | Curb Slope | 7.5 |

**Remove & Replace Curb Ramp With Two New Directional Ramps or Equivalent.**

**R304.2.2, R304.5.1, STD 1115**
