# Access Compliance Report Public Rights-of-Way (Curb Ramps)

Main Street: PROSPECT\_AVE Cross Street: LEAFWOOD\_LN Location: SW

ADA ID: RPAT211018151039 Ramp Type: Type 3 - Combination 1 Initial Pass/Fail: Fail Overall Compliance: No Severity Score: 5

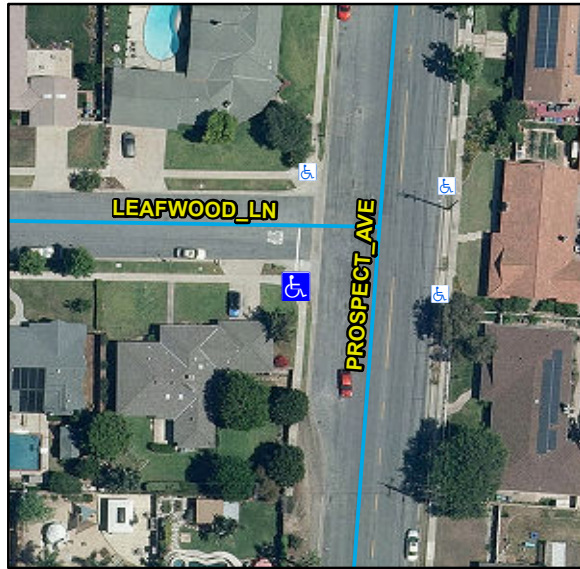
**R304.2.2, R204.3, R304.5.1, R304.5.3, STD 1115**

**Remove & Replace Curb Ramp With Two New Directional Ramps or Equivalent. Remove & Replace Sidewalk.**

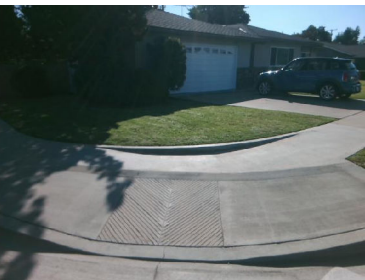
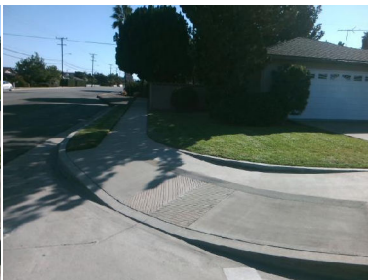
| Compliance | Description | Data | Compliance | Description | Data |
|---|---|---|---|---|---|
| No | Ramp Width LT (in) | 44 | Yes | Ramp Width RT (in) | 57 |
| No | Ramp Cross Slope LT (%) | 3.4 | Yes | Ramp Cross Slope RT (%) | 0.2 |
| No | Perp Joint Present | No | | | |
| N/A | Gutter Ponding | N/A | No | Curb Slope | 8.8 |
