# Access Compliance Report Public Rights-of-Way (Curb Ramps)

Main Street: LAURINDA\_WAY Cross Street: SANTA\_CLARA\_AVE Location: SW

ADA ID: RPAT211019085824 Ramp Type: Type 1 - Perpendicular Diagonal Initial Pass/Fail: Fail Overall Compliance: No Severity Score: 4

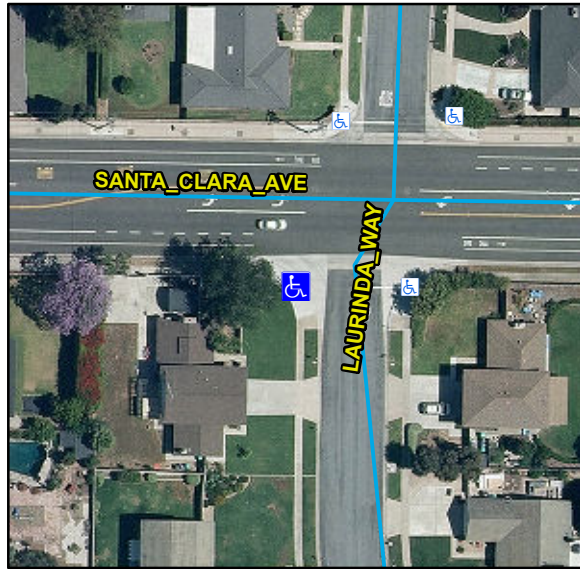
**R304.2.2, R304.5.1, STD 1115**

| Compliance | Description | Data | Compliance | Description | Data |
|---|---|---|---|---|---|
| No | Ramp Width (in) | 47 | | | N/A |

**Remove & Replace Curb Ramp With Two New Directional Ramps or Equivalent.**
