# Access Compliance Report Public Rights-of-Way (Curb Ramps)

Main Street: E\_SANTA\_CLARA\_AVE Cross Street: LAURINDA\_WAY Location: SE

ADA ID: RPAT211019090130 Ramp Type: Type 1 - Perpendicular Diagonal Initial Pass/Fail: Pass Overall Compliance: No Severity Score: 4

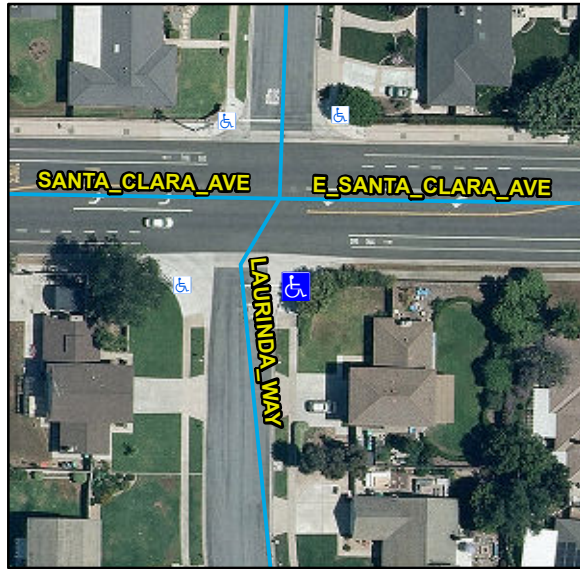
| Compliance | Description | Data | Compliance | Description | Data |
|---|---|---|---|---|---|
| Yes | Gutter Ponding | No | No | Curb Slope | 11.3 |

Remove & Replace Curb Ramp With Two New Directional Ramps or Equivalent.

R304.2.2, R304.2.1, STD 1115
