# Access Compliance Report Public Rights-of-Way (Curb Ramps)

| Main Street: FLINT_DR | | Cross Street: SANTA_CLARA_AVE | | Location: | NE |
| ADA ID: RPAT211019091612 | Ramp Type: Type 4 - Parallel | Initial Pass/Fail: Pass | Overall Compliance: No | Severity Score: | 0 |

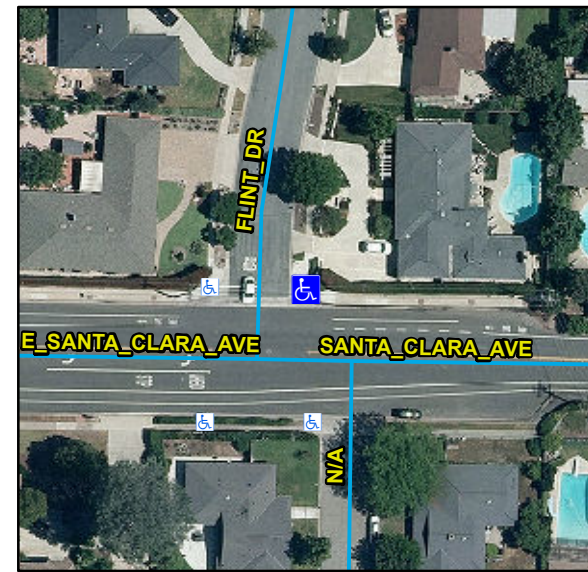
| Compliance | Description | Data | Compliance | Description | Data |
|---|---|---|---|---|---|
| No | Gutter Ponding | Yes | No | Curb Slope | 9.3 |
| Yes | Gutter Lip Height (in) | 0 | | Road Run Slope (%) | 1.5 |

Possible Solutions:

**Remove & Replace Curb Slope.**

**R304.2.2, R302.7, STD 1115**

Total Cost: \$ 252

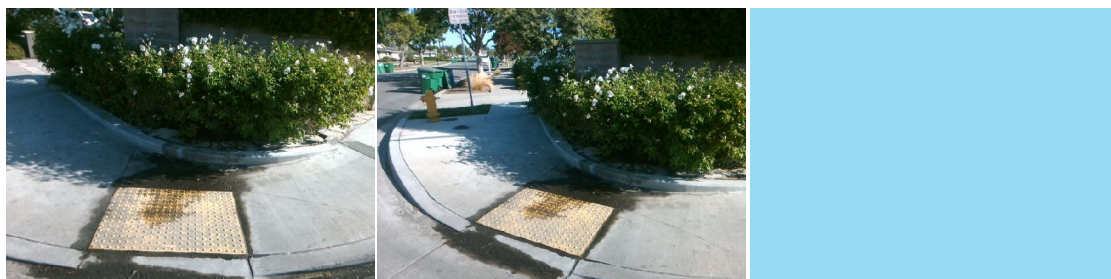
| Compliance | Description | Data | Compliance | Description | Data |
| N/A | Ramp Length LT (in) | 128 | N/A | Ramp Length RT (in) | 88 |
| Yes | Ramp Width LT (in) | 80 | Yes | Ramp Width RT (in) | 57 |
| Yes | Ramp Run Slope LT (%) | 7.9 | Yes | Ramp Run Slope RT (%) | 7 |
| Yes | Ramp Cross Slope LT (%) | 1.2 | Yes | Ramp Cross Slope RT (%) | 0.9 |
