# Access Compliance Report Public Rights-of-Way (Curb Ramps)

Main Street: E\_SANTA\_CLARA\_AVE Cross Street: FLINT\_DR Location: NW

ADA ID: RPAT211019092149 Ramp Type: Type 4 - Parallel Initial Pass/Fail: Fail Overall Compliance: No Severity Score: 15

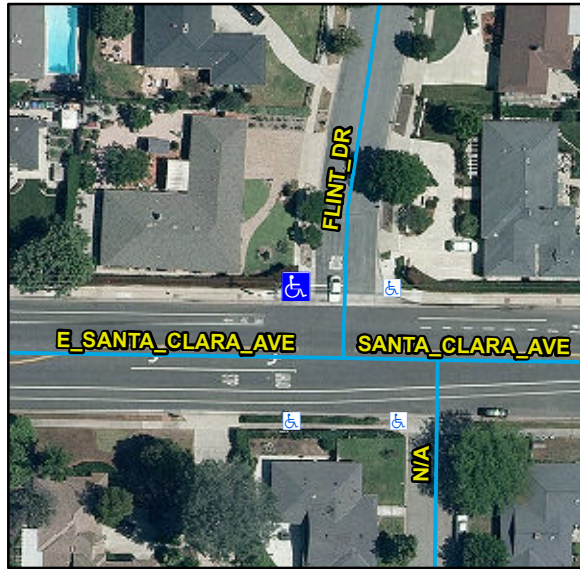
| Compliance | Description | Data | Compliance | Description | Data |
|---|---|---|---|---|---|
| Yes | Ramp Run Slope LT (%) | 6.4 | No | Ramp Run Slope RT (%) | 9.2 |

Remove & Replace Curb Ramp With Two New Directional Ramps or Equivalent.

R304.3.2, STD 1115
