# Access Compliance Report Public Rights-of-Way (Curb Ramps)

| Main Street: LAURINDA_WAY | | Cross Street: E_SANTA_CLARA_AVE | | Location: | NE |

| ADA ID: RPAT211019092803 | Ramp Type: Type 4 - Parallel | Initial Pass/Fail: Fail | Overall Compliance: No | Severity Score: | 16 |

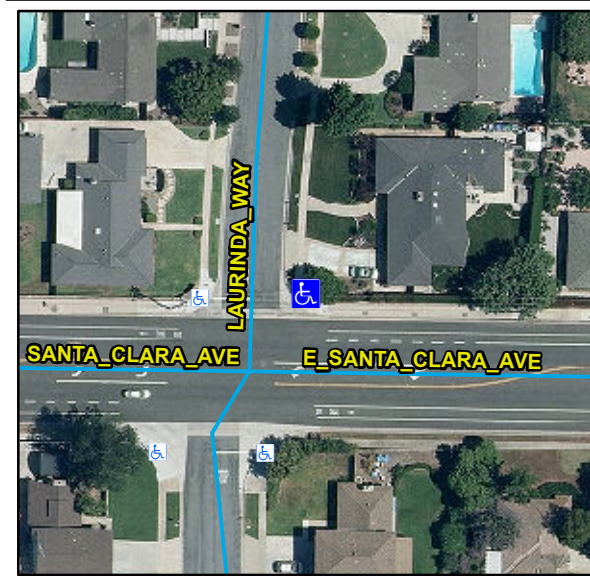
| Compliance | Description | Data | Compliance | Description | Data |
|---|---|---|---|---|---|
| No | Ramp Run Slope LT (%) | 8.4 | Yes | Ramp Run Slope RT (%) | 6.9 |
| No | Ramp Cross Slope LT (%) | 2.2 | Yes | Ramp Cross Slope RT (%) | 0.7 |

**Remove & Replace Curb Ramp With Two New Directional Ramps or Equivalent.**

**R304.3.2, R304.5.3, STD 1115**

Total Cost: \$ 4000

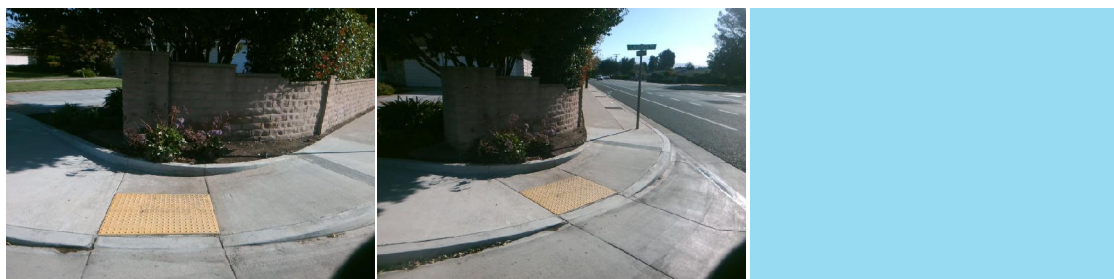
| Compliance | Description | Data | Compliance | Description | Data |
|---|---|---|---|---|---|
| N/A | Ramp Length LT (in) | 117 | N/A | Ramp Length RT (in) | 86 |
| Yes | Ramp Width LT (in) | 75 | Yes | Ramp Width RT (in) | 61 |
