# Access Compliance Report Public Rights-of-Way (Curb Ramps)

| Main Street: SANTA_CLARA_AVE | | Cross Street: LAURINDA_WAY | | Location: | NW |
| ADA ID: RPAT211019093147 | Ramp Type: Type 4 - Parallel | Initial Pass/Fail: Fail | Overall Compliance: No | Severity Score: | 15 |

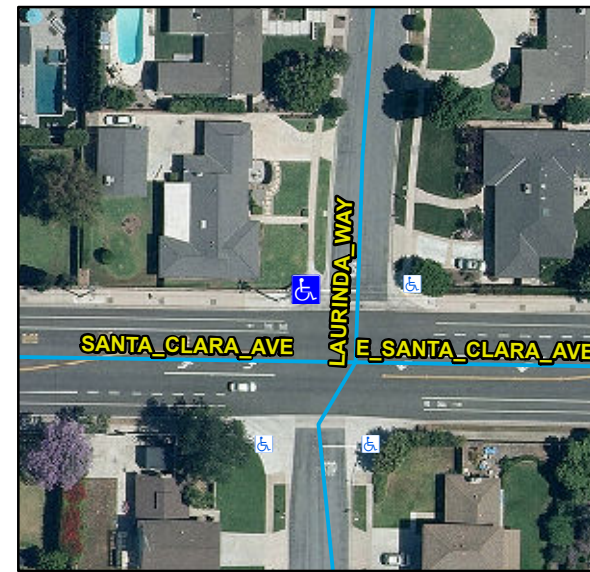
| Compliance | Description | Data | Compliance | Description | Data |
|---|---|---|---|---|---|
| Yes | Ramp Run Slope LT (%) | 7.1 | No | Ramp Run Slope RT (%) | 8.9 |

**Remove & Replace Curb Ramp With Two New Directional Ramps or Equivalent.**

**R304.3.2, STD 1115**

Total Cost: \$ 4000
