# Access Compliance Report Public Rights-of-Way (Curb Ramps)

Main Street: MALENA\_DR Cross Street: SANTA\_CLARA\_AVE Location: NE

ADA ID: RPAT211019093606 Ramp Type: Type 1 - Perpendicular Diagonal Initial Pass/Fail: Pass Overall Compliance: No Severity Score: 0

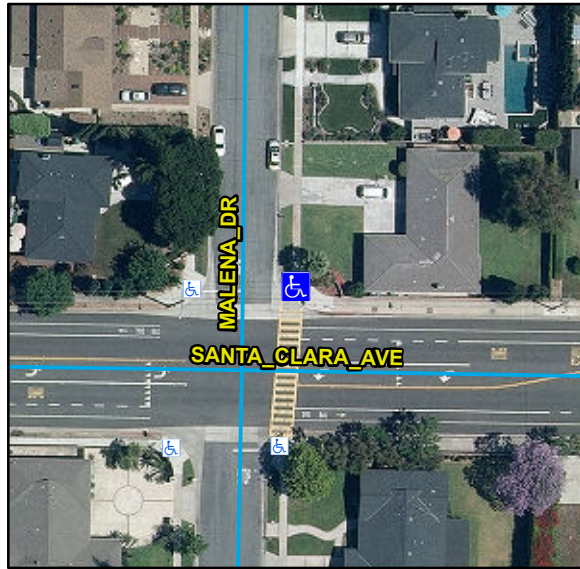
R304.2.2, R304.2.1, STD 1115

| Compliance | Description | Data | Compliance | Description | Data |
|---|---|---|---|---|---|
| Yes | Gutter Ponding | No | No | Curb Slope | 11.6 |

Remove & Replace Curb Ramp With Two New Directional Ramps or Equivalent.
