# Access Compliance Report Public Rights-of-Way (Curb Ramps)

Main Street: SANTA\_CLARA\_AVE Cross Street: MALENA\_DR Location: NW

ADA ID: RPAT211019094127 Ramp Type: Type 1 - Perpendicular Diagonal Initial Pass/Fail: Pass Overall Compliance: No Severity Score: 0

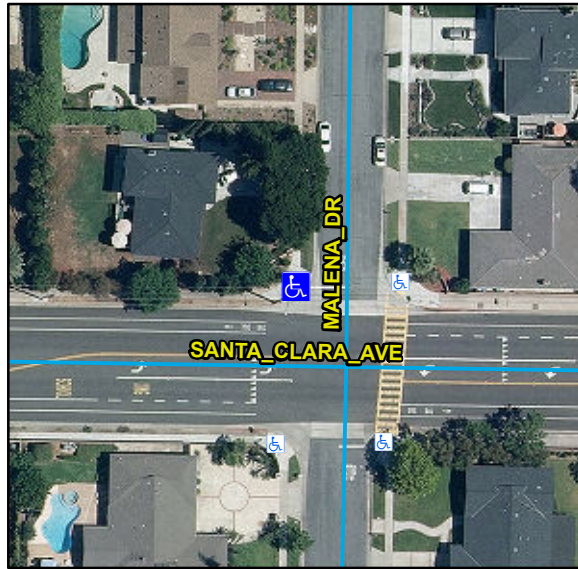
| Compliance | Description | Data | Compliance | Description | Data |
|---|---|---|---|---|---|
| Yes | Gutter Ponding | No | No | Curb Slope | 5.2 |

Remove & Replace Curb Ramp With Two New Directional Ramps or Equivalent.

R304.2.2, R304.2.1, STD 1115
