# Access Compliance Report Public Rights-of-Way (Curb Ramps)

Main Street: WHEELER\_PL Cross Street: SANTA\_CLARA\_AVE Location: NE

ADA ID: RPAT211019094635 Ramp Type: Type 1 - Perpendicular Diagonal Initial Pass/Fail: Pass Overall Compliance: No Severity Score: 6

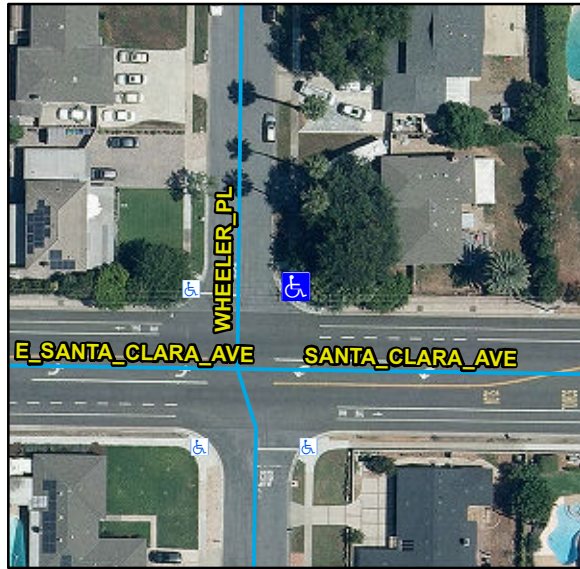
| Compliance | Description | Data | Compliance | Description | Data |
|---|---|---|---|---|---|
| No | Ramp Cross Slope (%) | 2.3 | N/A | Flare Traversable LT | No |
| No | Gutter Run Slope (%) | 7.3 | | Road Cross Slope (%) | 2.3 |

Remove & Replace Curb Ramp With Two New Directional Ramps or Equivalent. Remove & Replace Gutter.

R304.5.3, R304.5.4, STD 1115
