# Access Compliance Report Public Rights-of-Way (Curb Ramps)

Main Street: **E\_SANTA\_CLARA\_AVE** Cross Street: **WHEELER\_PL** Location: **NW**

ADA ID: **RPAT211019095300** Ramp Type: **Type 1 - Perpendicular Diagonal Initial Pass/Fail: Pass** Overall Compliance: **No** Severity Score: **0**

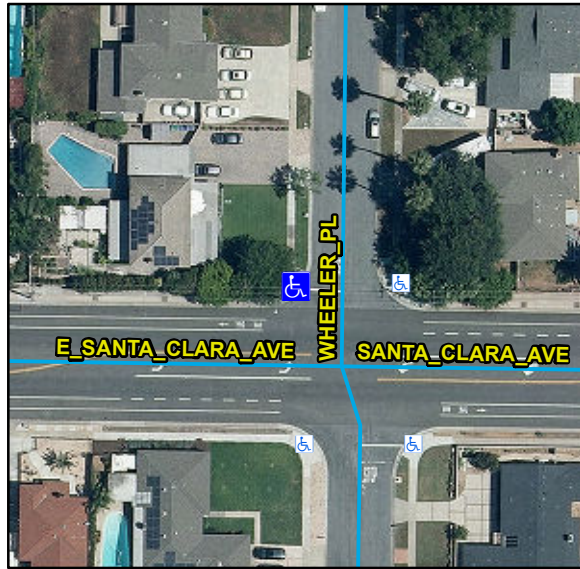
| Compliance | Description | Data | Compliance | Description | Data |
|---|---|---|---|---|---|
| <b>No</b> | Gutter Cross Slope (%) | <b>2.1</b> | | | |

**Remove & Replace Landing. Remove & Replace Gutter.**

**R304.2.1, R304.5.3, STD 1115**
