# Access Compliance Report Public Rights-of-Way (Curb Ramps)

Main Street: MALENA\_DR Cross Street: SANTA\_CLARA\_AVE Location: SW

ADA ID: RPAT211019100558 Ramp Type: Type 1 - Perpendicular Diagonal Initial Pass/Fail: Pass Overall Compliance: No Severity Score: 0

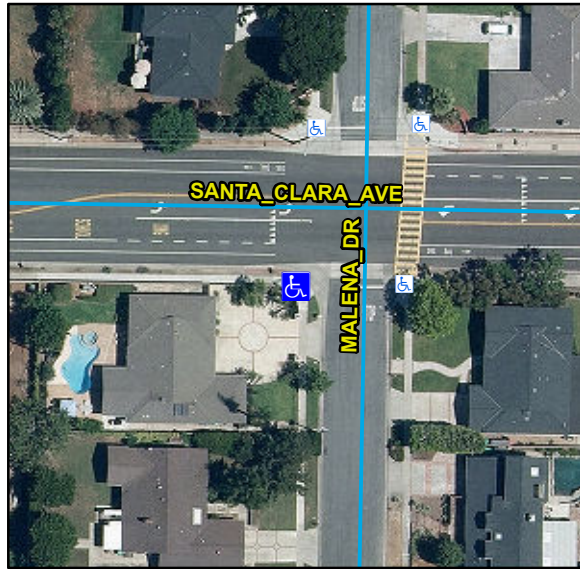
| Compliance | Description | Data | Compliance | Description | Data |
|---|---|---|---|---|---|
| Yes | Gutter Ponding | No | No | Curb Slope | 5.3 |

Remove & Replace Curb Ramp With Two New Directional Ramps or Equivalent.

R304.2.2, R304.2.1, STD 1115

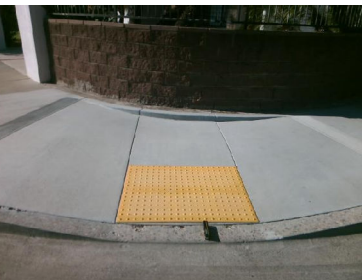
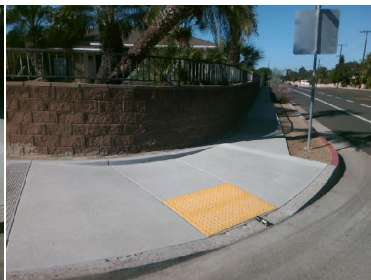
| Compliance | Description | Data | Compliance | Description | Data |
|---|---|---|---|---|---|
| Yes | Overall Surface Condition: Acceptable | | Yes | Perp Joint Present | Yes |
