# Access Compliance Report Public Rights-of-Way (Curb Ramps)

Main Street: SANTA\_CLARA\_AVE Cross Street: MALENA\_DR Location: SE

ADA ID: RPAT211019100949 Ramp Type: Type 1 - Perpendicular Diagonal Initial Pass/Fail: Pass Overall Compliance: No Severity Score: 0

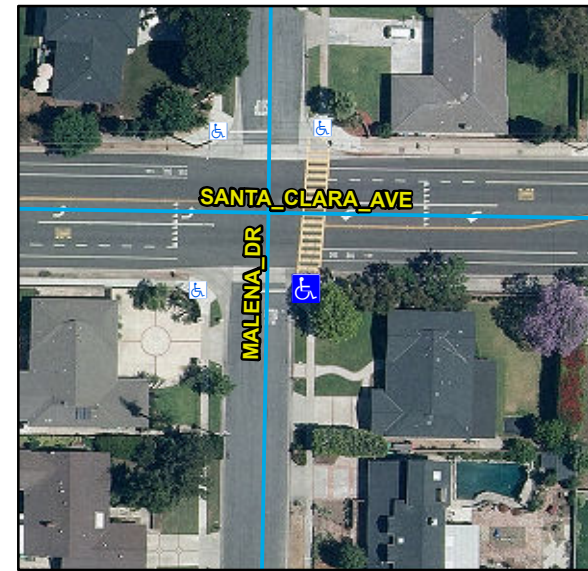
| Compliance | Description | Data | Compliance | Description | Data |
|---|---|---|---|---|---|
| N/A | Landing Movement Obstructed? | Yes | Yes | DWS Contrast | Yes |
| | Landing Movement Type | Curb | Yes | DWS Length (in) | 36 |

Possible Solutions:

Remove & Replace Landing.

R304.2.1, STD 1115
