# Access Compliance Report Public Rights-of-Way (Curb Ramps)

Main Street: CARLSBAD\_DR Cross Street: JOSHUA\_LN Location: SE

ADA ID: RPAT211019102949 Ramp Type: Type 1 - Perpendicular Diagonal Initial Pass/Fail: Pass Overall Compliance: No Severity Score: 22

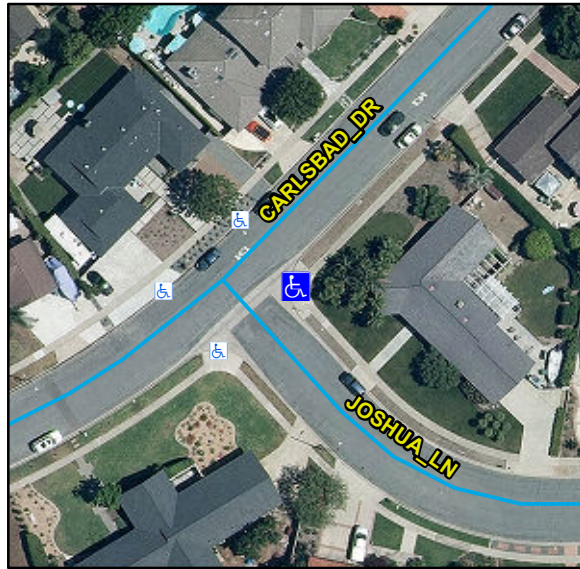
| Compliance | Description | Data | Compliance | Description | Data |
|---|---|---|---|---|---|
| N/A | Ramp Length (in) | 112 | N/A | Flare Type LT | |
| Yes | Ramp Width (in) | 62 | | | Sloped |
| Yes | Ramp Run Slope (%) | 5.2 | N/A | Flare Slope LT (%) | 5.7 |
| Yes | Ramp Cross Slope (%) | 1.1 | N/A | Flare Traversable LT | No |
| N/A | Landing Present | No | N/A | Flare Type RT | |
| No | Landing Width (in) | N/A | N/A | Flare Slope RT (%) | 6.9 |
| No | Landing Run Slope (%) | N/A | N/A | Flare Traversable RT | No |
| No | Landing Cross Slope (%) | N/A | No | DWS Provided | No |

Remove & Replace Curb Ramp With Two New Directional Ramps or Equivalent.
