# Access Compliance Report Public Rights-of-Way (Curb Ramps)

Main Street: JOSHUA\_LN Cross Street: CARLSBAD\_DR Location: SW

ADA ID: RPAT211019103928 Ramp Type: Type 1 - Perpendicular Diagonal Initial Pass/Fail: Pass Overall Compliance: No Severity Score: 16

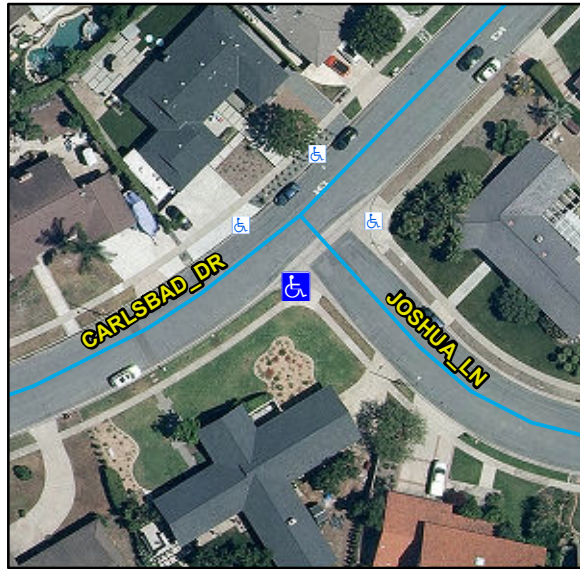
| Compliance | Description | Data | Compliance | Description | Data |
|---|---|---|---|---|---|
| No | Landing Run Slope (%) | 3.9 | N/A | Flare Traversable RT | No |
| No | Landing Cross Slope (%) | 2.4 | No | DWS Provided | No |
| Yes | Overall Surface Condition: Acceptable | | No | Perp Joint Present | No |

Remove & Replace Curb Ramp With Two New Directional Ramps or Equivalent.
