# Access Compliance Report Public Rights-of-Way (Curb Ramps)

| Main Street: YELLOWSTONE_DR | | Cross Street: CARLSBAD_DR | | Location: | NE |
| ADA ID: RPAT211019104630 | Ramp Type: Type 1 - Perpendicular Diagonal Initial Pass/Fail: Pass | | Overall Compliance: No | Severity Score: | 22 |

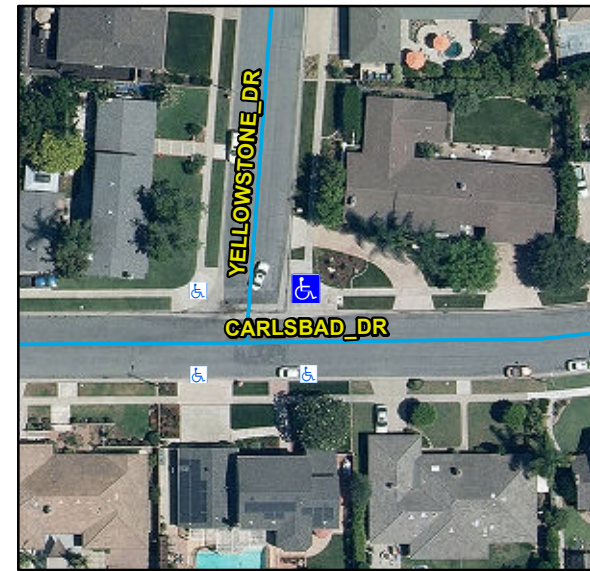
| Compliance | Description | Data | Compliance | Description | Data |
|---|---|---|---|---|---|
| No | Landing Width (in) | N/A | N/A | Flare Slope RT (%) | 5.1 |
| No | Landing Run Slope (%) | N/A | N/A | Flare Traversable RT | No |
| No | Landing Cross Slope (%) | N/A | No | DWS Provided | No |
| N/A | Landing Movement Obstructed? | Yes | N/A | DWS Contrast | N/A |
| | Landing Movement Type | Curb | N/A | DWS Length (in) | N/A |

**Remove & Replace Curb Ramp With Two New Directional Ramps or Equivalent.**

**R204.3, R304.2.1, R304.2.2-Perp, R304.3.2-Para, R304.5.3, R305, STD 1115**

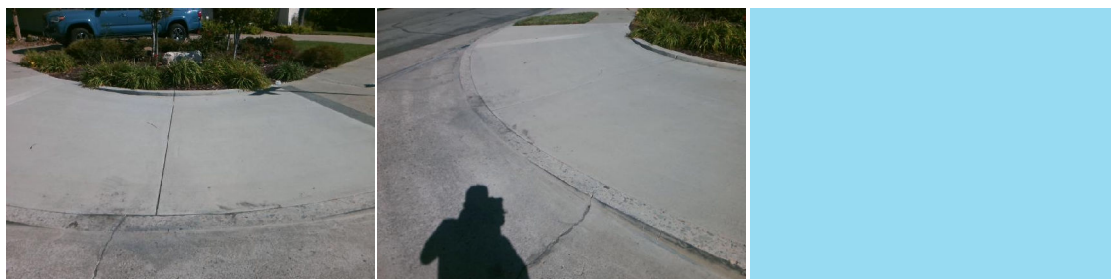
| Compliance | Description | Data | Compliance | Description | Data |
|---|---|---|---|---|---|
| Yes | Overall Surface Condition: Acceptable | | No | Perp Joint Present | No |
| | Cross Gutter Present? | Yes | | Spandrel Present? | Yes |
| | Replace Cross Gutter? | No | | Replace Spandrel? | No |
