# Access Compliance Report Public Rights-of-Way (Curb Ramps)

Main Street: CARLSBAD\_DR Cross Street: YELLOWSTONE\_DR Location: NW

ADA ID: RPAT211019105016 Ramp Type: Type 1 - Perpendicular Diagonal Initial Pass/Fail: Pass Overall Compliance: No Severity Score: 16

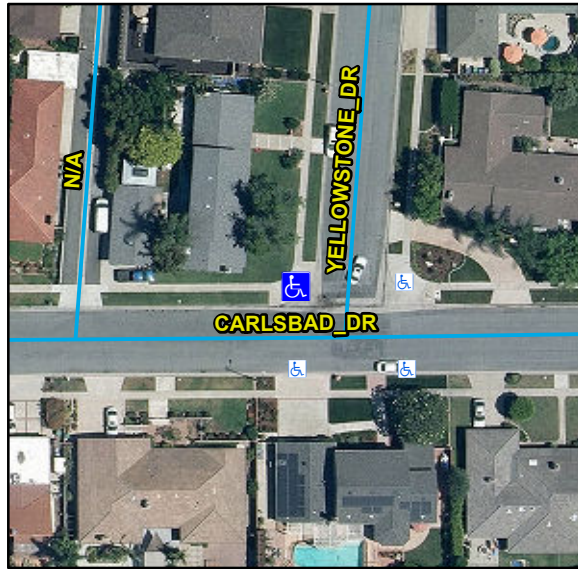
| Compliance | Description | Data | Compliance | Description | Data |
|---|---|---|---|---|---|
| No | Landing Run Slope (%) | 2.5 | N/A | Flare Traversable RT | No |
| Yes | Landing Cross Slope (%) | 0.1 | No | DWS Provided | No |

Remove & Replace Curb Ramp With Two New Directional Ramps or Equivalent.

R204.3, R304.2.1, R304.2.2-Perp, R304.3.2-Para, R305, STD 1115
