# Access Compliance Report Public Rights-of-Way (Curb Ramps)

Main Street: CARLSBAD\_DR Cross Street: ESTES\_WAY Location: E

ADA ID: RPAT211019110001 Ramp Type: Type 1 - Perpendicular Diagonal Initial Pass/Fail: Pass Overall Compliance: No Severity Score: 14

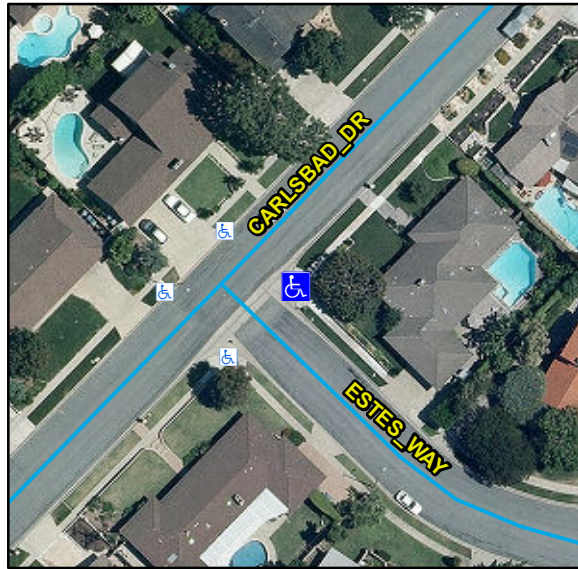
| Compliance | Description | Data | Compliance | Description | Data |
|---|---|---|---|---|---|
| No | Landing Run Slope (%) | 3.2 | N/A | Flare Traversable RT | No |
| Yes | Landing Cross Slope (%) | 1.7 | No | DWS Provided | No |

Remove & Replace Curb Ramp With Two New Directional Ramps or Equivalent.
