# Access Compliance Report Public Rights-of-Way (Curb Ramps)

Main Street: **ESTES\_WAY** Cross Street: **CARLSBAD\_DR** Location: **SW**

ADA ID: **RPAT211019110322** Ramp Type: **Type 1 - Perpendicular Diagonal** Initial Pass/Fail: **Fail** Overall Compliance: **No** Severity Score: **15**

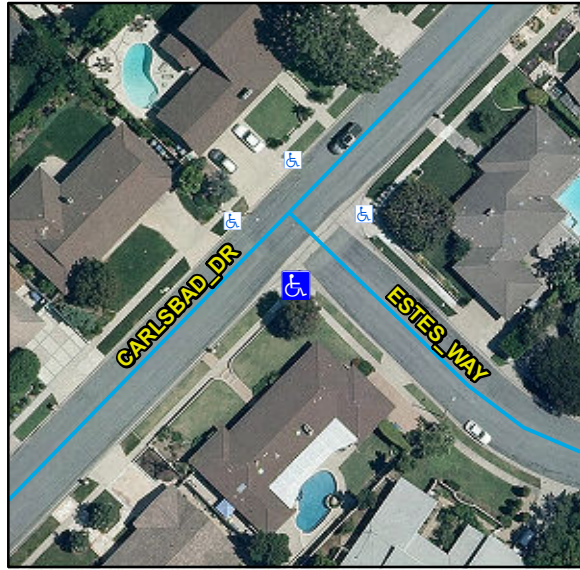
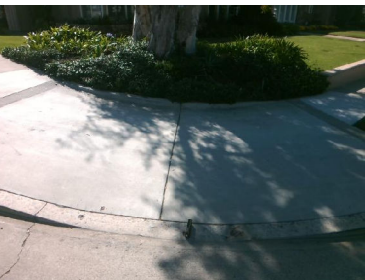
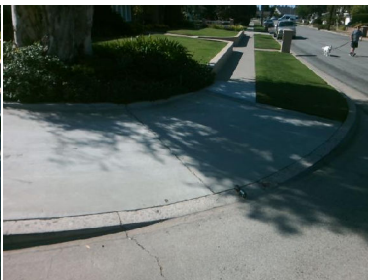
| Compliance | Description | Data | Compliance | Description | Data |
|---|---|---|---|---|---|
| <b>No</b> | Ramp Cross Slope (%) | <b>6.8</b> | <b>N/A</b> | Flare Traversable LT | <b>N/A</b> |

**Remove & Replace Curb Ramp With Two New Directional Ramps or Equivalent.**
