# Access Compliance Report Public Rights-of-Way (Curb Ramps)

Main Street: CARLSBAD\_DR Cross Street: LEAFWOOD\_LN Location: NE

ADA ID: RPAT211019111148 Ramp Type: Type 1 - Perpendicular Diagonal Initial Pass/Fail: Fail Overall Compliance: No Severity Score: 2

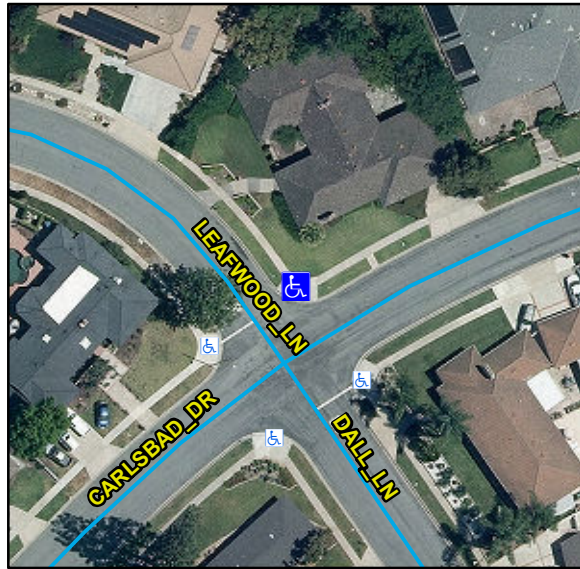
| Compliance | Description | Data | Compliance | Description | Data |
|---|---|---|---|---|---|
| No | Ramp Cross Slope (%) | 2.4 | N/A | Flare Traversable LT | N/A |

Remove & Replace Curb Ramp With Two New Directional Ramps or Equivalent.

R204.3, R304.5.3, STD 1115
